From: Planning Support
Subject: FW: HGY/2021/2571 (HGY/2020/1326) Land At Townsend Yard, London N6 5JF

Ref: - 36A Highgate High Street. HGY/2021/2571 (HGY/2020/1326) Land At Townsend Yard, London N6 5JF

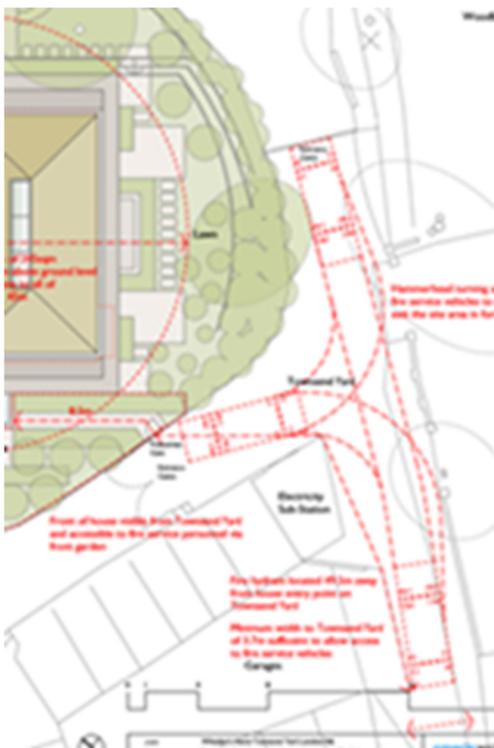
A fire appliance has attended the site in an attempt to use the current provisions for access and facilities for the Fire Service. As displayed by the plan below:

*It was found that an appliance was able to enter the road and reverse back into the turn around point. However, the driver of said appliance, supported by the officer in charge, were **unable** to exit out of the turn around point and drive back towards the access point / main road in a forward gear.*

On questioning, it was discovered that the provision was too tight (due to obstructions i.e. tree etc) to undertake the appropriate manoeuvre.

As a result of the lack of a turning provision, the fire appliance reversed out of Townsend Rd onto the main access road, in a slow and careful manner (due to the narrow width of the road/

bollard obstructions). This reversing ultimately led to a delay in leaving the site, which would reduce the amount of available time a fire crew would have, should they need to attend an incident, if deployed from the site. Furthermore the access provisions, do not practically meet the requirements of Approved Document B- B5.
